More than
primary stability.
The new tapered standard.

Casebook

ON THE STRAUMANN® BONE LEVEL TAPERED IMPLANT

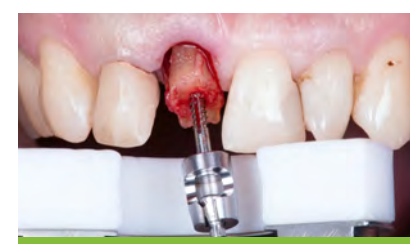
(FIG. 3)

Before tooth extraction an impression was taken with transparent silicone (FIG. 3). After administration of the local anesthetic and a releasing incision in the sulcus, the coronal part of the tooth was removed with forceps. After tooth extraction the alveolar socket was checked with a probe. The mesial vestibular wall was intact and there was no fenestration (FIG. 4). Based on CBCT a Straumann® Bone Level Tapered (BLT) SLA 4.1/12 implant was selected. Implant-bed preparation was performed without flap elevation to minimize trauma. The drilling axis was moved to the palatal direction to achieve better primary stability and a better implant position (along the palatal axis). The implant was placed (FIG. 5), including a surgical unit and an insertion torque of 19Ncm. Immediate non-functional loading of the implant with the temporary crown on the final abutment was performed. For esthetic reasons a RC Straumann® Anatomic IPS e.max GH3.5 mm, MO1, zirconia abutment was selected. The occlusal adjustment of the coronal part of the abutment was carried out with the diamond cylinder (FIG. 6) on a high-speed turbine with intensive water-cooling. A temporary crown was created from light-cured enamel HFO composite with transparent silicone index (FIG. 7). The abutment was placed as a first step, to create the temporary crown, but augmentation of the socket was not yet performed to avoid infiltration of material / composite. When the crown was finished (chair-side), the abutment was unscrewed and replaced with the Loxim® for insertion of the biomaterial. The abutment and crown were placed back in position after this. Vestibular tunneling was carried out to create a space for connective tissue graft (CTG) from the palate. The CTG was fixed with a suture and augmentation of the space between the implant and vestibular bone plate of the socket was carried out with a xenograft material (Cerabone®) (FIG. 8). After completion of this step, the final abutment was placed. The access to the fixing screw was closed with Teflon tape. The crown was made out composite and was light-cured on the prefabricated abutment. As a temporary solution, this allowed placement of the crown on the abutment without cement because of the extremely tight fit. Chlorhexidine gel was used to lubricate the surface of the abutment during insertion of the crown to enable easy positioning. A sling suture technique for multiple recession was used to stabilize the coronal position of the vestibular soft tissue mobilized by tunneling (FIG. 9). The sutures were removed after 2 weeks.

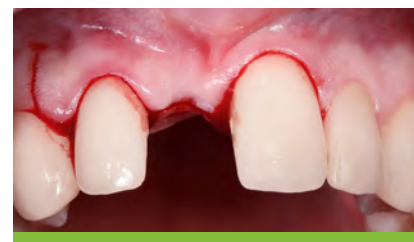
(FIG. 2)

A prosthetically driven planning approach was used to define the esthetic parameters of the final reconstruction (FIG. 2). The hard tissue was analyzed radiographically and the decision was made to use a Straumann® Roxolid® SLA Bone Level Tapered (BLT) 3.3 mm implant of 14 mm length. An antibiotic, amoksilav 1000 mg, was given orally 1 hour before surgery. The same prophylactic antibiotic was given orally for 7 days after the operation. During this time the patient was advised to rinse with 0,2% chlorhexidine digluconate solution for 1 minute three times a day. To minimize scarring of the soft tissue, an intrasulcular incision was performed around teeth #21 and 12, slightly palatal over the crest of position 11, with a single releasing incision between the papilla apex and the zenith of the emergence profile of tooth 13 (FIG. 3). Due to the thin nature of the crestal bone, particularly on the buccal wall, it was decided to perform bone splitting using the Piezzo technic (FIG. 4). Following this, the final implant osteotomy was prepared with the recommended surgical drills for the Straumann

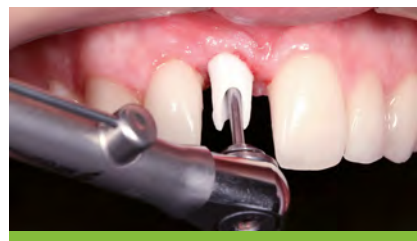
(FIG. 13)

The final abutment was torqued to 35 Ncm without incident 14 weeks later (FIG.13) and the final ceramic prosthesis was permanently luted using Multilink implant cement. The final position of the emergence profile of tooth 11 matches that of tooth #21, and although the papilla between teeth # 13 and 12 is not symmetrical to that of the tooth #21 and 22 the result was very pleasing and well achieved.

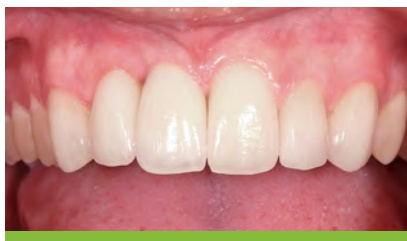
(FIG. 14)

The wishes and expectations of the patient were fulfilled and he was very pleased with the final outcome (FIG. 14).

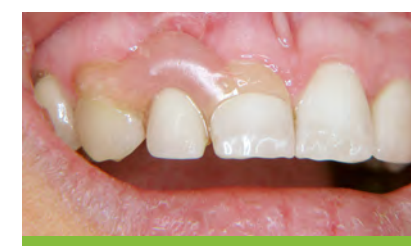
(FIG. 1)

A 34-year-old female presented with a missing upper right lateral incisor (tooth #12). The tooth had been extracted 6 months earlier, and a removable prosthesis had been used (FIG. 1). Prior to the extraction, the tooth had a history of apical pathology and had been treated with an apicectomy and subsequent connective tissue graft to increase thickness of the mucosa. The residual ridge exhibited moderate atrophy after the loss of the tooth (FIG. 2).

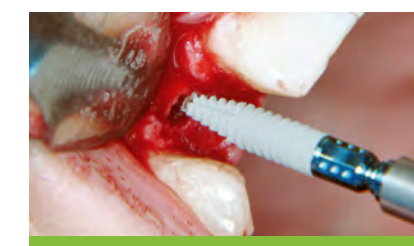
A full thickness mucoperiosteal flap was raised on the buccal aspect (without vertical releasing incisions) and a facial bony undercut was detected. A Bone Level Tapered (BLT) SLActive Roxolid® implant was inserted (FIG. 3) and an ISQ value of 64-65 was recorded (FIG. 4). A mix of autogenous bone chips (harvested during drilling of the implant site) mixed with allograft bone particles (C+TBA allograft) was placed in the buccal defect, without the use of a membrane. A radiograph confirmed the satisfactory position of the BLT implant (FIG. 5). Primary closure was achieved and the implant was allowed to heal as a two-stage procedure. A resin-splinted tooth was fabricated and cemented as a temporary prosthesis (FIGS. 6, 7).

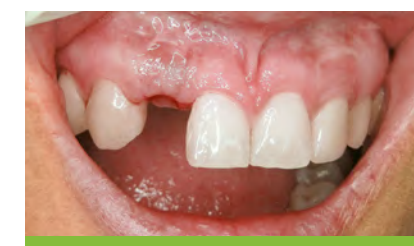
After 8 weeks of healing, the temporary prosthesis was removed (FIG. 8) and the implant was uncovered using a mucosal punch without raising a flap. An ISQ value of 73-74 was recorded. A provisional screw-retained crown was fabricated chair-side using the Regular CrossFit® (RC) temporary abutment (FIGS. 9,10). In the following 3 weeks, the provisional restoration was modified so as to optimize the shape and contour of the soft tissues and emergence profile (FIGS. 11-14).

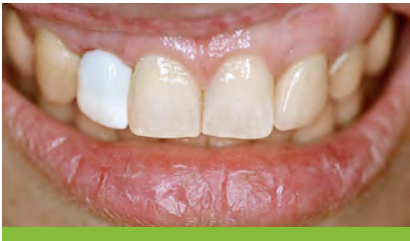
Following maturation of the soft tissues, impressions were taken using polyvinyl siloxane. A standard angulated abutment (RC angled 15° 2 mmGH abutment), which was minimally modified, was used (FIG. 15) and a zirconia cemented restoration was fabricated (FIG. 16).

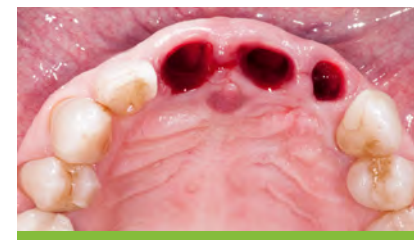
(FIG. 3)

An impression was taken with transparent silicone before extracting the teeth. The teeth were extracted under local anesthesia (FIG. 3). After checking the post-extraction sockets I decided to place the implants without flap elevation. Following visual inspection supported by CBCT pictures, two NC 3.3/14 mm Straumann® Bone Level Tapered (BLT) Roxolid® SLA implants were placed (FIG. 4). The depth of implant insertion was calculated with respect to the palatal bone level of the alveolar ridge. The insertion torque was over 30Ncm. The axis of the implant faced in vestibular direction. Two NC screw-retained abutments for the bridge with an angulation of 30° and a gingival height of 2.5 mm (FIG. 5) and two NC/RC copings for screw-retained abutments with a platform diameter 4.6 mm (FIG. 6) were selected. The cylinders were covered with thin opaque layer of composite to cover the silver color of the metal. From the initial silicone index a temporary bridge was created (FIG. 7) with an ovate pontic design in the position of the missing tooth #21. Access to the fixing screw was perfectly positioned on the palatal side of the restoration and was closed with the Teflon tape and layer of flow composite (FIG. 8). There was no need to use sutures. A control CBCT was taken after surgery. Perfect positioning was visible, illustrating the great advantage of the Bone Level Transplant (BLT) implant design, especially in the position of the missing tooth #22 where a narrow alveolar ridge was present (FIG. 9). Immediate non-functional loading required elimination of the occlusal contact points. After correcting the palatal surface of the bridge the patient was sent home with the instruction to avoid biting and chewing in contact with the bridge.

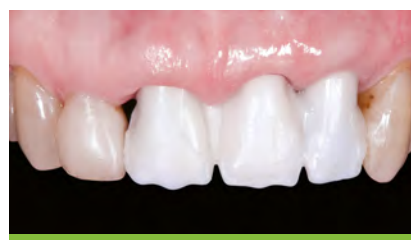
(FIG. 11)

The emergence profile of the soft tissue was shaped with the temporary bridge (FIG. 10). After 3 months of uneventful healing the bridge was unscrewed to check the status of the soft tissue. The healthy condition of the soft tissue allowed for the final prosthetic restoration. A screw-retained restoration based on the Prettau® structure was created. An impression was taken (abutment level) and sent to the laboratory. After a few days the Prettau® construction was checked in the mouth (FIG. 11). The final shape of the bridge was a compromise between the available soft tissue level and the minimalistic approach required by the patient. The bridge was a screw-retained reconstruction with the access to the screws on the palatal side. The tunnels were closed with Teflon tape and sealed with flow composite.

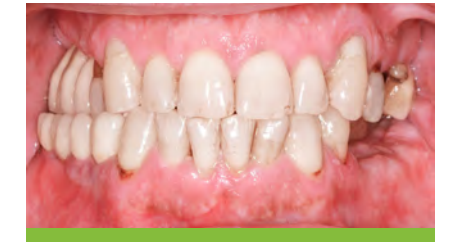
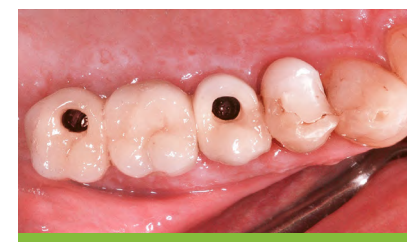
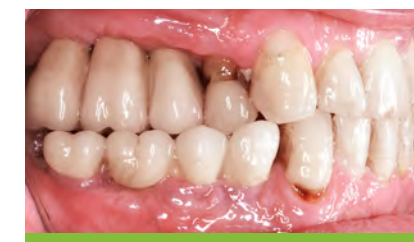
A try-in of the framework was done before the final restoration was delivered in order to check whether the components fitted well and to adjust the occlusal surfaces. The Multi-Base abutments were torqued at 35Ncm and the bridge at 15N/cm following the Straumann prosthetic protocol and a composite filling was placed in the screw access holes (FIGS. 12-14).

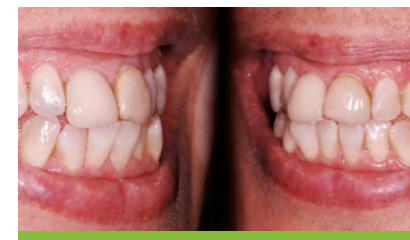
(FIG. 1)

A 60-year-old male patient presented with multiple decayed teeth and root remnants in the upper right and left, and lower left quadrants (FIGS. 1-3).

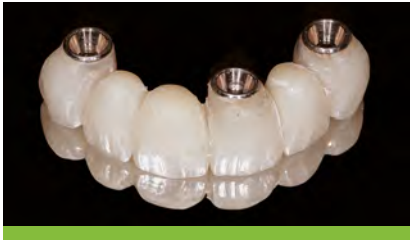
(FIG. 14)

An attempt was made to seat 17 degree 4 mm high screw retained abutments at all three sites but these did not fit due to the emergence of the abutment seating against the bone at the countersunk implant sites. The implants were protected with cover screws, and bone removal was carried out with burs through the wound margins. The abutments were seated and an abutment level impression was made for production of a plastic provisional implant supported bridge (FIGS. 13,14).

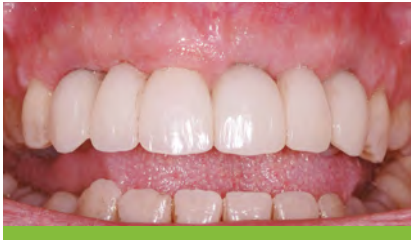
(FIG. 15)

The patient was reviewed 4 weeks after surgery and was satisfied with the outcome to date (FIG. 15). The tooth sizes and positions were agreeable and the lip support was not compromised. Clinically, there was no mobility or component looseness, and the tissues were pink and healthy. 1 mm of recession was noted at tooth #13, together with a moderate degree of papillary volume loss between the #13 implant and #12 pontic. The patient was reassured that on production of the definitive bridge this recession could be compensated for by using a 2.5 mm high multi-unit abutment if necessary.

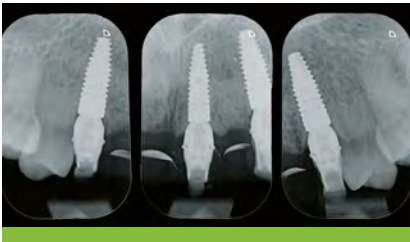
(FIG. 16)

Radiographs were taken 5 months after surgery to confirm favorable bone conditions around the implants (FIG. 16). The 4 mm height screw retained abutments placed at surgery were exchanged with 2.5 mm height abutments at positions 13, 21 so as to place the bridge-abutment junction 1.5 mm below the gingival margin (FIG. 17). This decision was taken to allow for a small degree of future tissue recession without aesthetic detriment. An abutment level impression was taken and a screw retained bridge framework was produced using CAD-CAM milling (CARES) and subsequently veneered with ceramic (Mr Raoul Stocchi, Shoenitz Dental Laboratory, Northwood Hills, UK). The final bridge was fitted to manufacturer screw torque recommendations and the access holes were closed with composite (FIGS. 18-20).

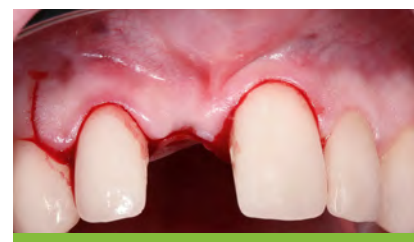
(FIG. 3)

After administering local anesthesia with idocaine 2%, a large surgical flap was raised with a vertical release incision on the side of the right cuspid in order not to jeopardize the existing 10-year-old implant replacing tooth #22. The fractured retained roots #12 and 21 were elevated and extracted in such a way as not to disturb the buccal bony plate. Both sockets were debrided; the drilling sequence was: 1.4 mm round burr at 800 rpm, 2.3 mm at 800 rpm, pilot drill 2.2 mm at 800 rpm, and finally pilot drill 2.8 mm at 800 rpm. Bone density was class 2, bone type was found to be closer to CI II; (FIG. 3).

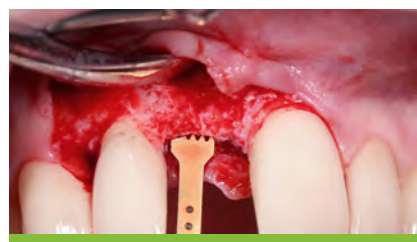
(FIG. 4)

Two implants were placed immediately: a Straumann® Roxolid® SLA 3.3 x14 mm Bone Level Tapered (BLT) implant to replace tooth #12, and a Straumann® Roxolid® SLActive 3.3 x 12 mm BLT implant to replace tooth #21. The insertion torque was around 35 N/cm (FIG. 4).

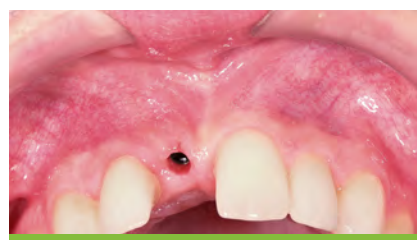
(FIG. 10)

implants, 0° screw retained abutments were placed and the wound was sutured using an resorbable suture (FIG. 10). The inserted implant position was then roughly transferred onto the temporary prosthesis using a bite registration material (Imprint™, Bite 3M ESPE) (FIG. 11). The opened holes were checked (FIG. 12) before attachment of the temporary abutments to the provisional prosthesis. A provisional full acrylic complete-arch prosthesis with temporary titanium copings was delivered on the day of surgery. The provisional prosthesis was screwed into the patient's mouth, his smile was checked (FIG. 13), and an OPG was taken (FIG. 14). In terms of oral hygiene, the patient was instructed to use chlorhexine for the first week then recommended to use an oral bath. The patient also instructed to maintain a soft diet for the first 6 weeks post-operatively.

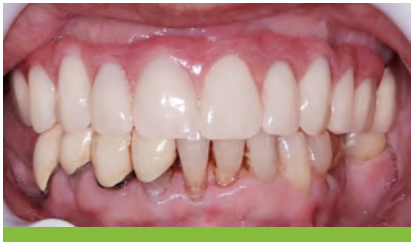
(FIG. 18)

Soft tissues around the implants were shaped with the emergence profile of the temporary bridge to allow easy access for cleaning. The bridge was removed to assess healing 3 weeks after exposure (FIG. 10) and the interior fitting surface was cleaned and polished. Impressions were taken in silicone putty 4 weeks later, (FIG. 11); the accuracy of the impression and working model was checked with a resin jig (FIG. 12), followed by occlusal registration (FIG. 13) and try-in of the wax-up. The master model, which included a soft tissue mask, was scanned using the Straumann® CARES® software. A wrap-around framework was designed (FIG. 14) and milled. (FIG. 15) The framework was tried in the patient's mouth and was passive (FIG. 16). The acrylic / metal bridge was fabricated (FIG. 17) and fitted on the screw-retained abutments, torquing the prosthetics screws to 15Ncm. Screw holes were sealed with PTFE tape and pink / white resin (FIGS. 18-21).

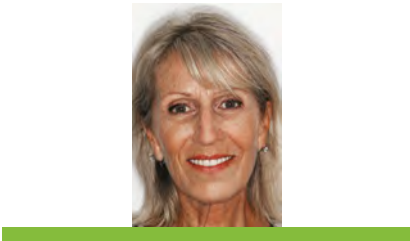
(FIG. 22)

The bridge was removed at follow-up 4 weeks after fitting; oral hygiene was excellent and there were no signs of any inflammation or pocketing. The bridge was cleaned and resealed, torquing the prosthetics screws to 15Ncm as recommended. The patient was extremely happy with the outcome (FIG. 22).

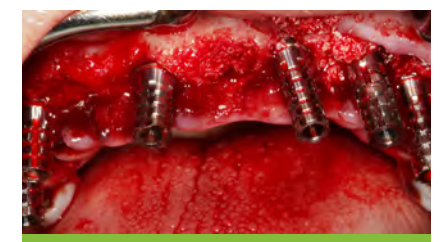
(FIG. 6)

The hollowed out temporary bridge was seated over the titanium copings and the two were fused together with self-curing resin (FIGS. 6, 7). Soft tissues around the implants were shaped with the emergence profile of the temporary bridge to allow easy access for cleaning The bridge was removed 3 weeks after expo-

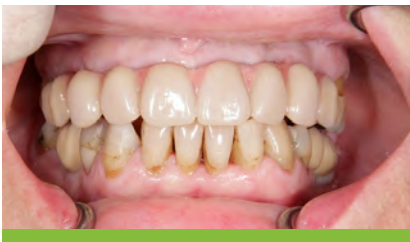
(FIG. 13)

BLT implants were successfully used to rehabilitate this patient’s maxillary and mandibular arches, despite the complexity of the case. The immediate stability achieved, even within the sockets, was so high that the temporary bridge could be fitted as planned. The CARES® software provided a totally passive titanium framework using a polished metal fitting surface. Cleaning with the power-wash should be easy and at follow-up there was no sign of any debris collecting around the implants (FIGS. 13, 14).
